HILBERINKBOSCH
ARCHITECTEN

Sheepfold

Recreational house

2023

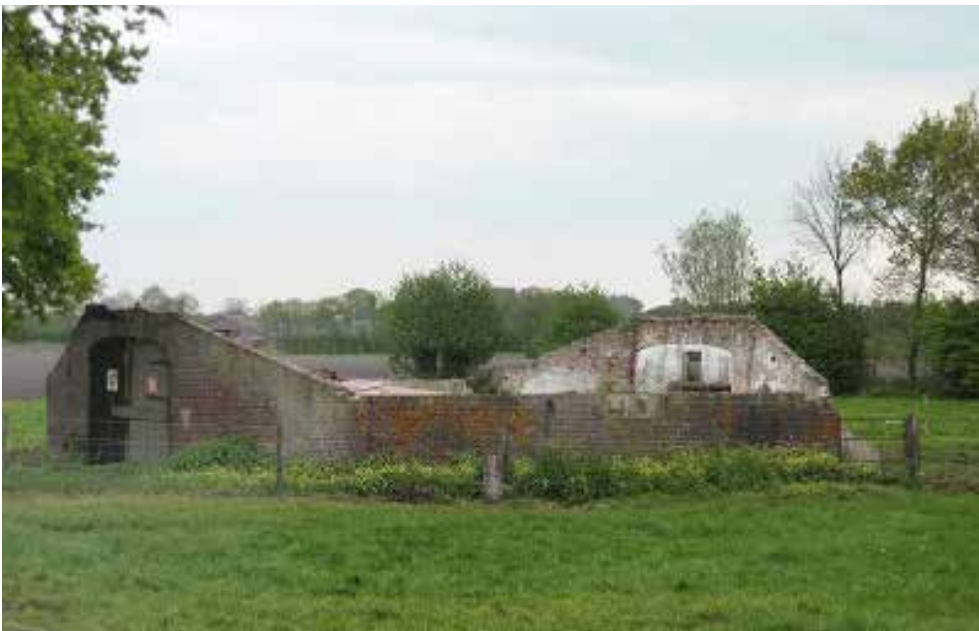
ruin Sheepfold 2021

From the end of the 19th century, sheepfolds fell into disuse with the use of artificial fertilisers and the reclamation of heathland, making sheep farming for manure no longer necessary. After serving as pigsties for some time, the sheepfolds lose their usefulness in agricultural operations and are demolished. Of this last sheepfold, a national monument that escaped total demolition, only parts of the brick outer walls remain.

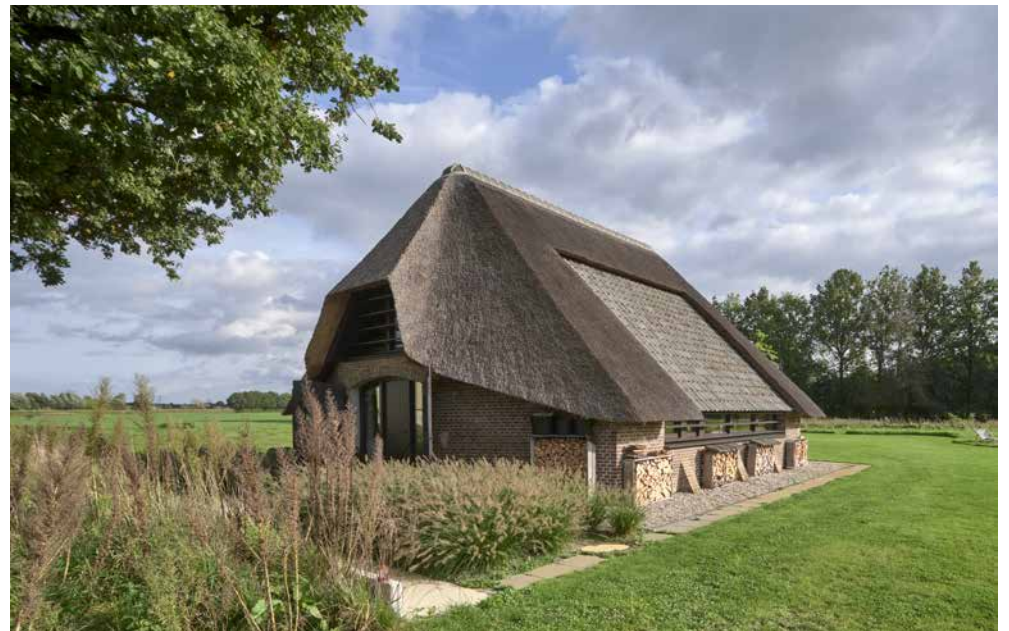
rebuild Sheepfold 2023

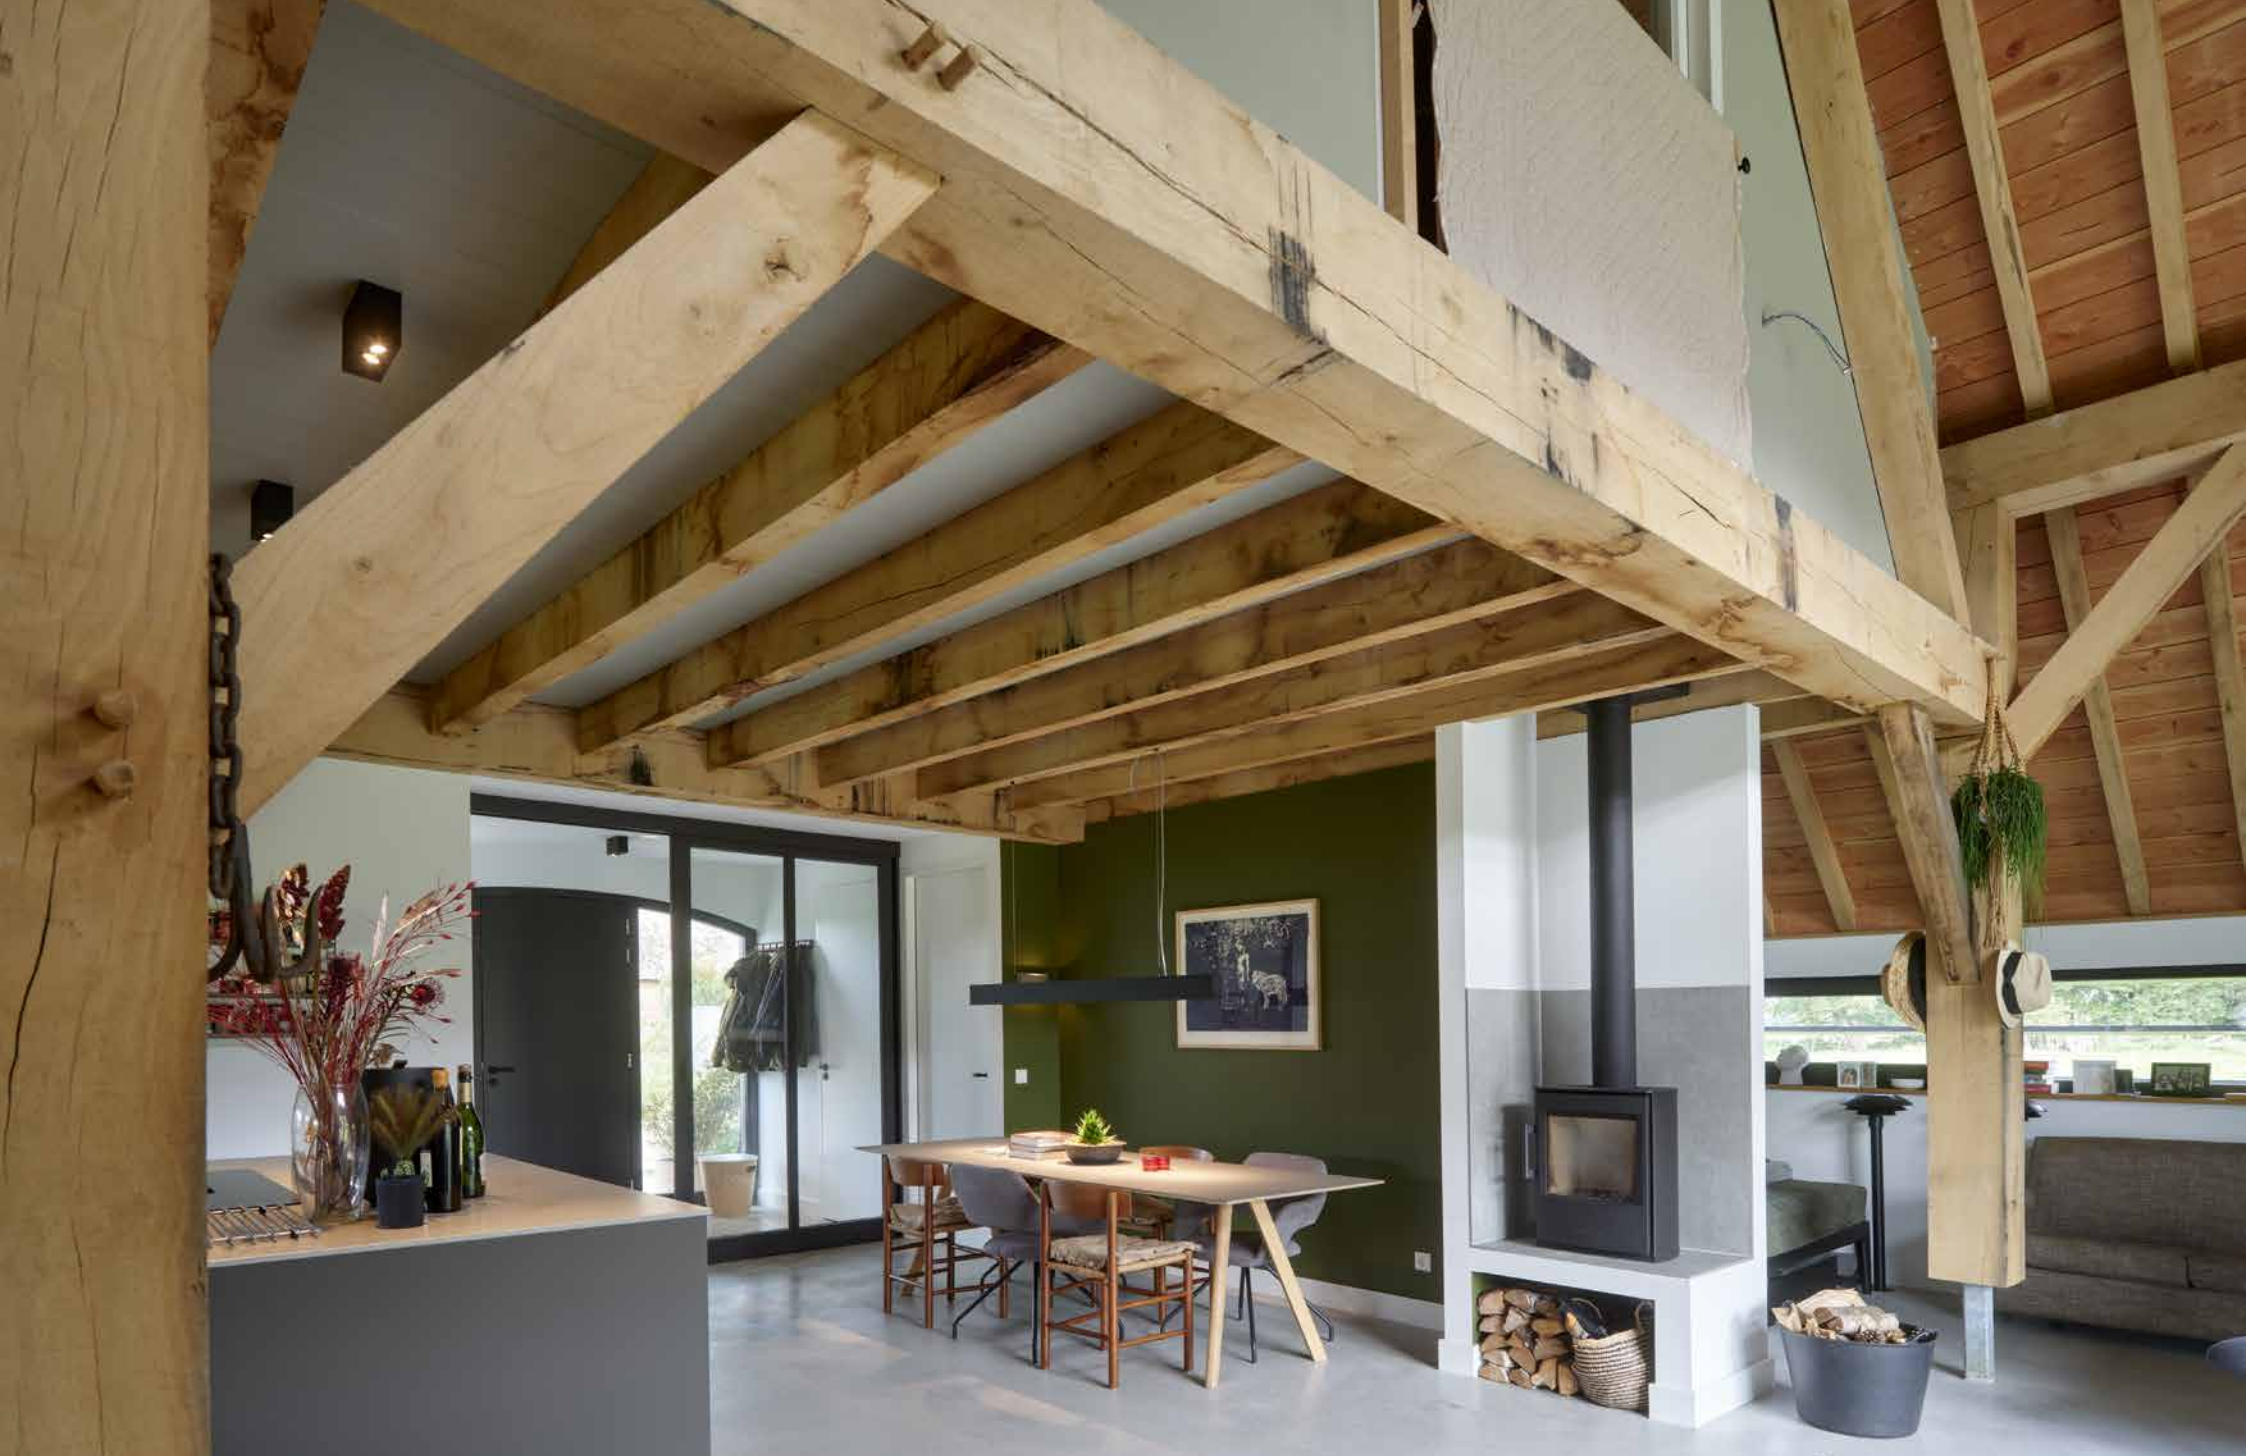
the old trusses and the rafter roof have been rebuilt using modern timber construction techniques

Modern timber construction techniques are used to rebuild the old trusses and the rafter roof. Space has been created between the trusses for a bedroom and bathroom without affecting the characteristic contours of the sheepfold. In the interior, the visible timber construction determines the atmosphere and the spaciousness of open sheepfold is guaranteed.
